Hello, and welcome to your Reserve Study!

3- Minute Executive Summary

Association: Hi Country Haus CIRA **Assoc. #: 19960-0**
Location: Winter Park, CO
of Units: 314
Report Period: January 1, 2010 through December 31, 2010

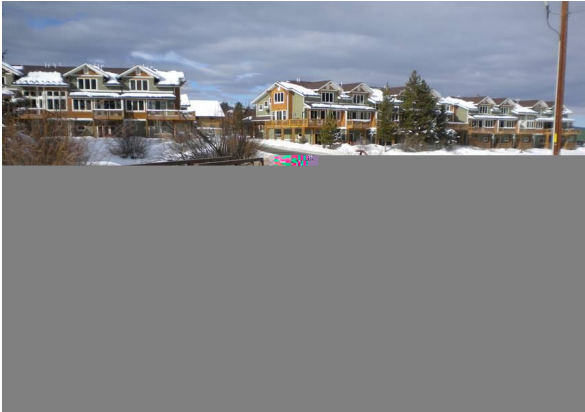
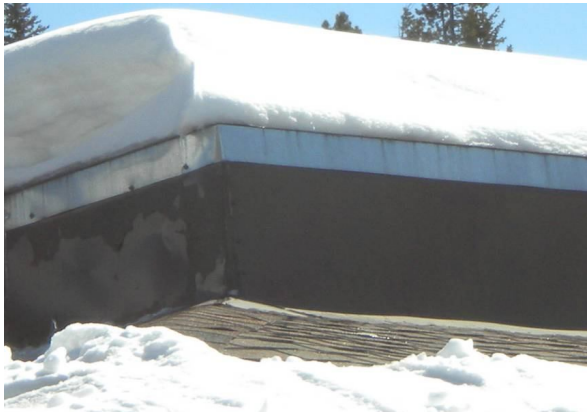
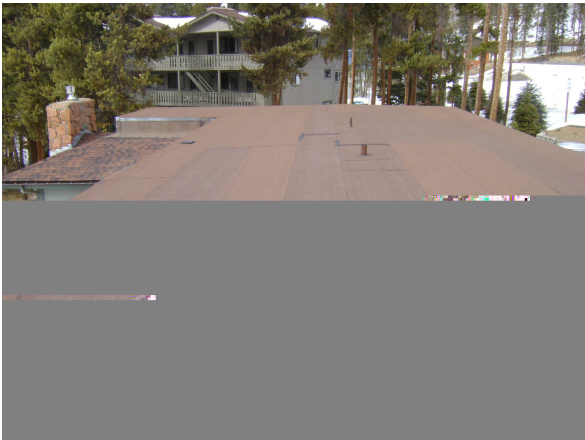
Again, due to snow levels, we were not able to fully inspect the bridges or their substructures. While we do anticipate a replacement of the wood bridge in 2030, we do not anticipate replacing the metal bridge if it receives regular maintenance and inspections by a qualified engineer.

We also noted that the flat portion of the clubhouse roof was covered in a rolled roofing material. While the roof appears to be recently applied, it was leaking at the time of inspection. A rolled roof has many material seams that will need close inspection and regular maintenance. *Note:* the rolled roof photo of the clubhouse was sent to us by The Roofing Company. We recommend that an EPDM-type roof be utilized for the next replacement cycle. This direct-bonded, rubberized roofing material will prove much more durable in our mountainous climate.
